Pine Creek/Sulphurbeds Allotment:
Dipping Vat Spring
Mary O'Brien
Grand Canyon Trust

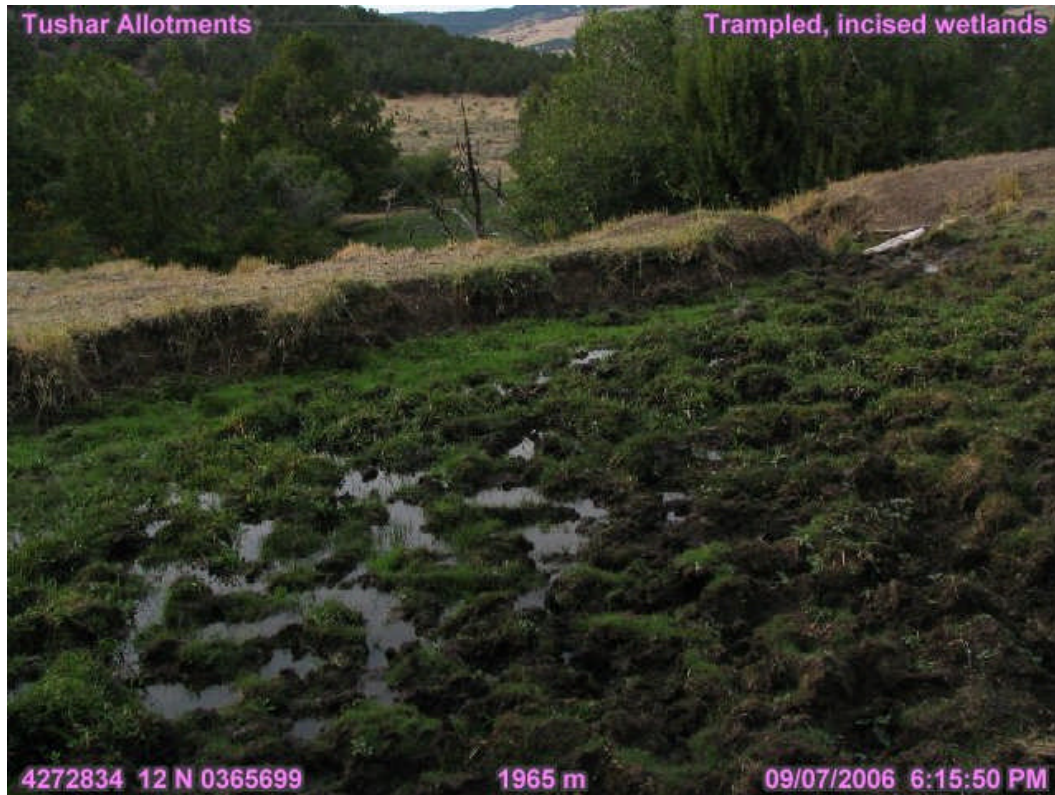
Dipping Vat Spring is a currently un-used sheep watering trough, with a pipe disconnected to a watering trough, and trampled, incised, over-grazed spring-seep wetlands below (Fig. 1). The land adjacent to the wetlands is overgrazed (Fig. 2) During 2008, the Cove Creek Pasture is being rested, and shows the potential for restoration of the wetlands (Fig. 3) via fencing, and piping of water further downslope.

Fig. 1 Pine Creek/Sulphurbeds: Wetlands below Dipping Vat Spring (in 2006; pasture was rested in 2008)

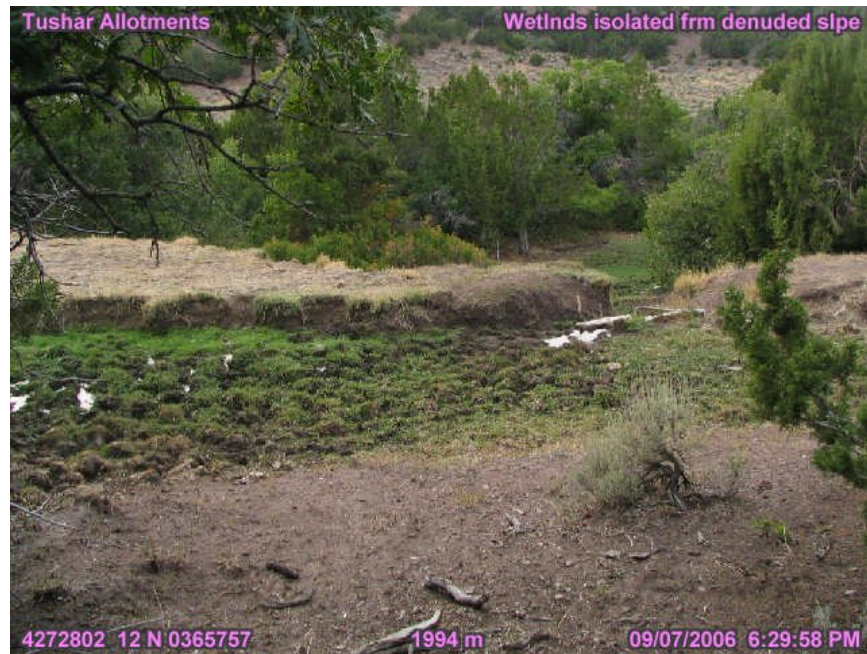
Fig. 2. PineCrk/Sulphurbeds: Denuded slope above incised Dipping Vat Springs wetlands (2006)

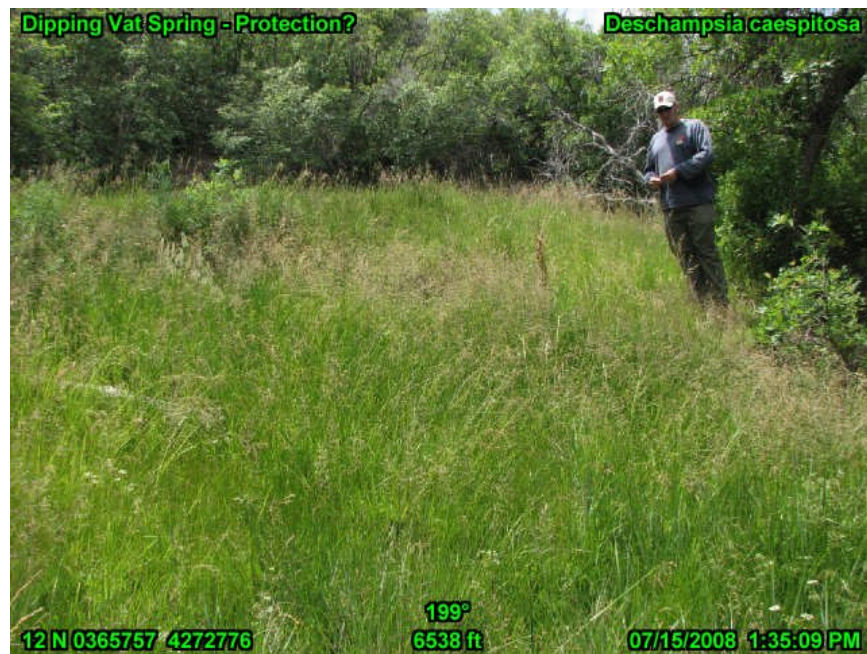
Fig. 3. Dipping Vat Spring wetland during a year it is rested. Tufted hairgrass (*Deschampsia caespitosa*) a wetland grass. Shows potential for protection of the wetland.
